BRAMFIELD AND THORINGTON PARISH COUNCIL

Bridge Street, Bramfield Highways Report 2025

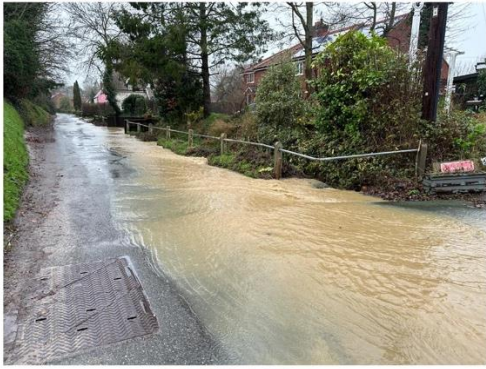
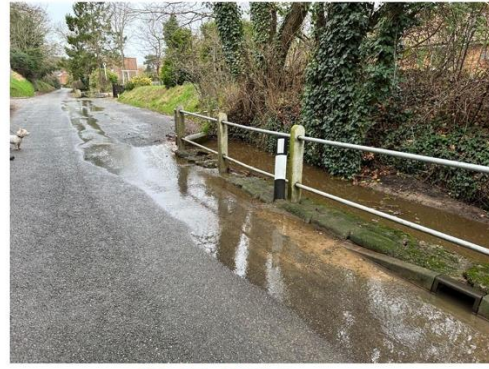
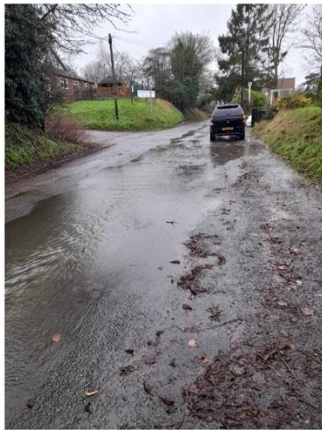
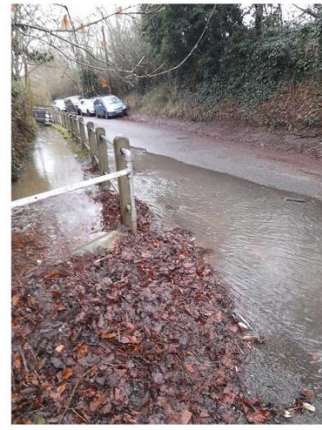
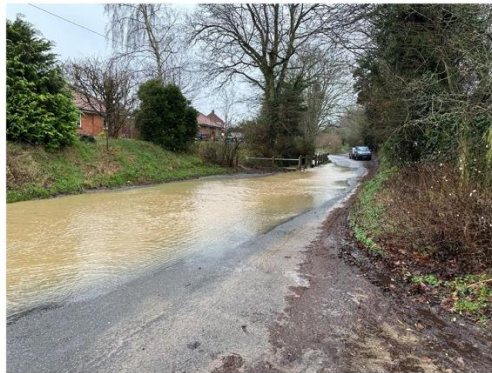
**These photographs are taken almost exactly a year apart - spot the difference!
Both of these images are taken on days when the primary school is open. It can
be clearly seen that the ditch is completely blocked and without the actions of
residents then considerably more damage would occur.**

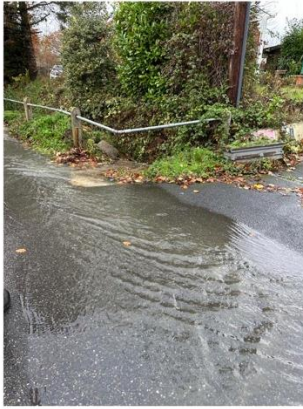
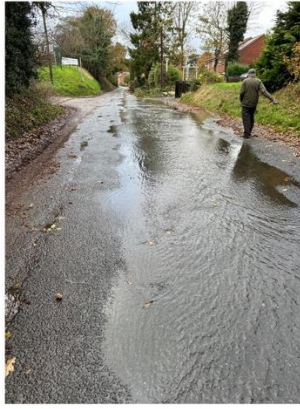
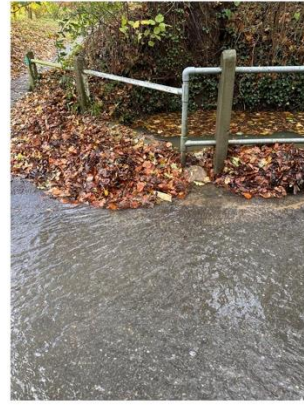
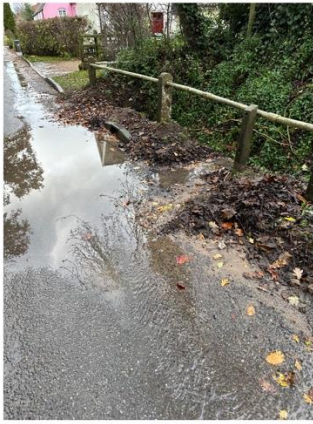
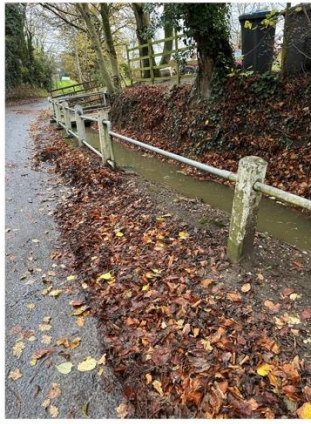
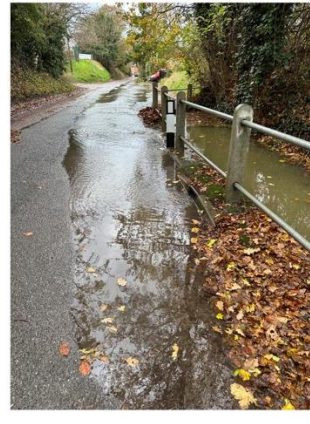
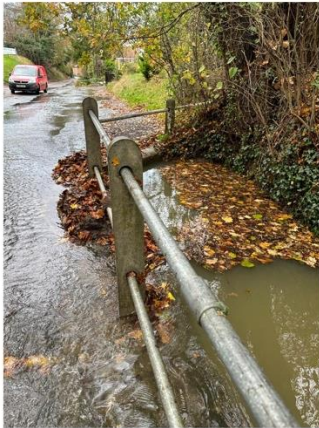
These photographs were taken on the 27th November 2024. This was on a school day at 13.44. These are the conditions that children were expected to walk through when leaving the school at the same time as traffic that normally traverses the road. As can be seen the ditch is completely blocked.

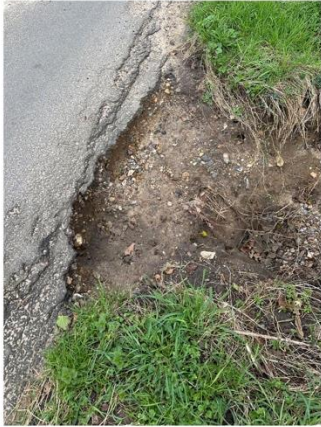
Fig 1

These photographs show the condition of the road once free of floods. As can be seen in all of the images, the road is eroding. The condition of the safety barriers is poor. The foundations for vertical concrete posts in figures 3,4,6,7 and 8 are becoming unstable. The metal horizontal barriers are loose and provide poor support.
