# **The Queen's Head Inn, Bramfield, Suffolk**

## **Heritage Asset Assessment**

**The Queen's Head Inn,  
The Street,  
Bramfield, Suffolk**

**Heritage Asset Assessment**

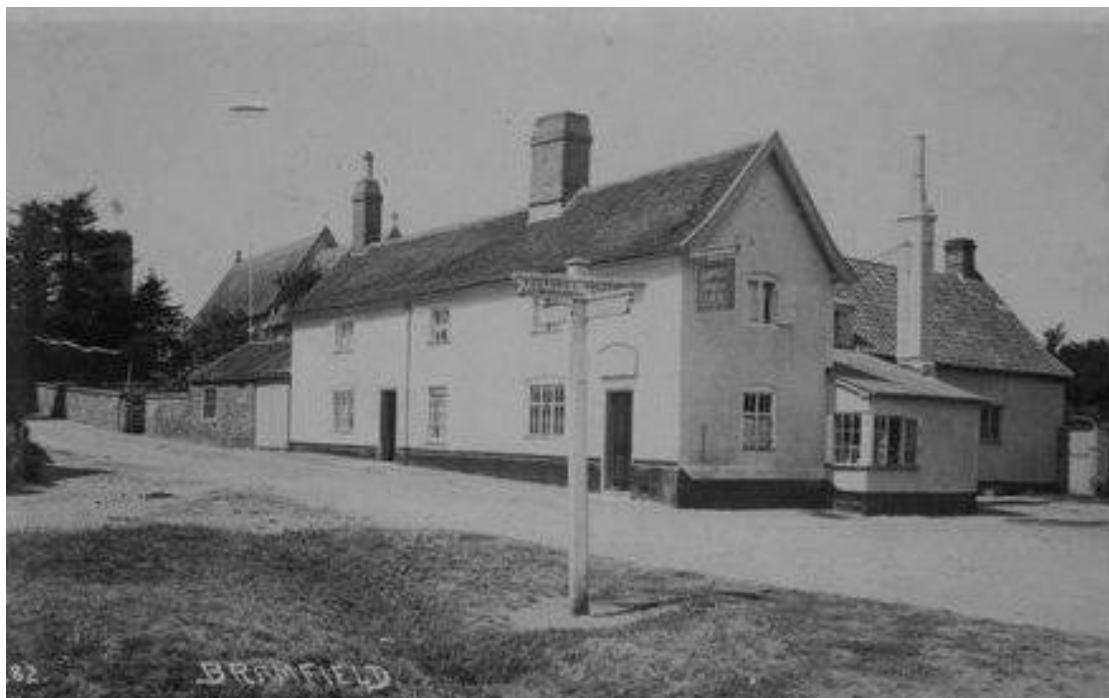
Figure 6. A postcard of the inn from the south-east taken in *circa* 1920. The southern elevation preserves its two original entrance doors but the present door in the eastern gable of the 18<sup>th</sup> century wing is conspicuous by its absence. Note the precariously tall chimney heating the eastern lean-to extension, which may have been the shoemaker's shop, necessary to clear the ridge of the nearby roof.

Illus. 1. The inn from the crossroads to the south-east showing the narrow 18<sup>th</sup> century wing (B) to the left of the lower 16<sup>th</sup> century range (A). The front (eastern) lean-to has been extended to the north since the 1920s (figures 6 & 7), removing the tall chimney, and the easternmost entrance of the cross-wing has moved to its gable.

**Illus. 3. The brick and tiled southern elevation of the narrow late-18<sup>th</sup> century wing. The present door was formerly wider (its original jamb is visible in the brickwork to its right), and the narrow window on the extreme right was initially a second entrance with closers (quarter-bricks) descending to the ground (figure 6).**

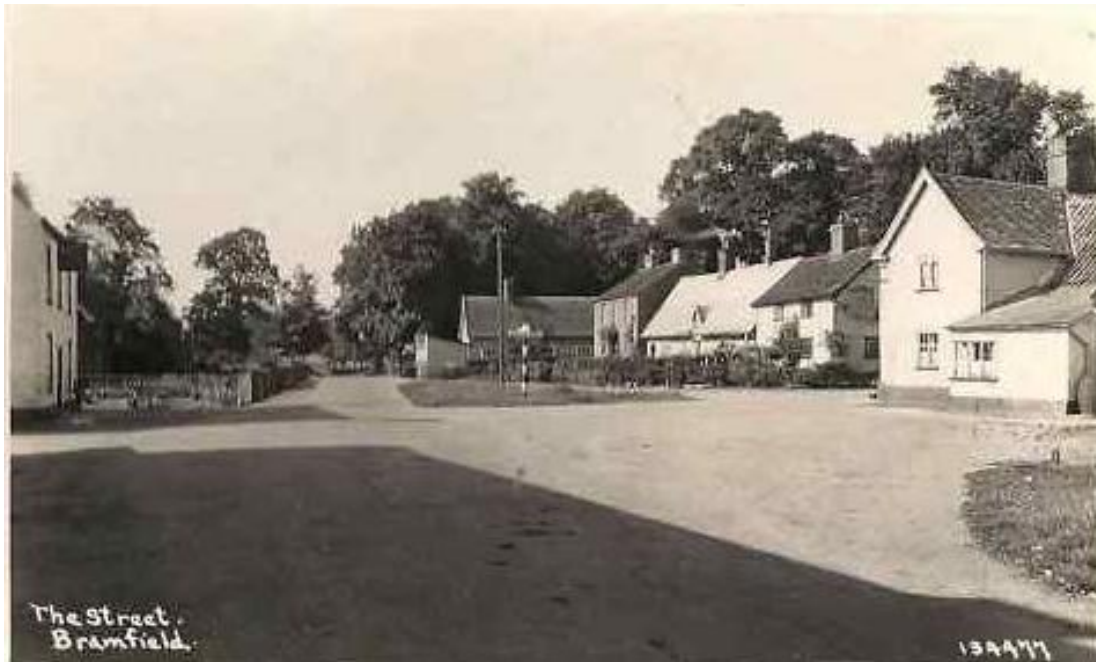
**Figure 7.** A postcard from The Street to the north in *circa* 1920, showing the broad crossroads in front of the inn.

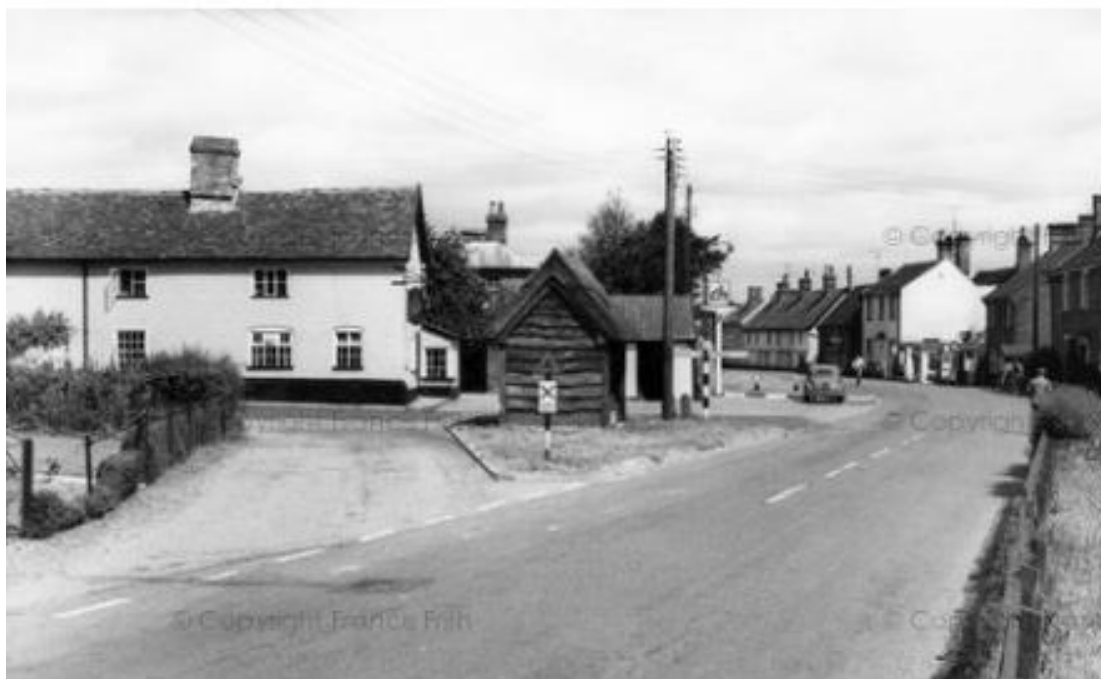
**Figure 8.** A postcard of 1955 from the south showing a thatched bus shelter with the since demolished single-story shed in front of the inn immediately to its right.

**Figure 2a. A detail of the building on the 1843 map with much the same outline that it retains today with the main structure in red and the outbuildings in grey. The detached L-shaped outbuilding to the north-east no longer survives but was shown as a single-storied shed in photographs of the 1950s and 60s (figure 8).**

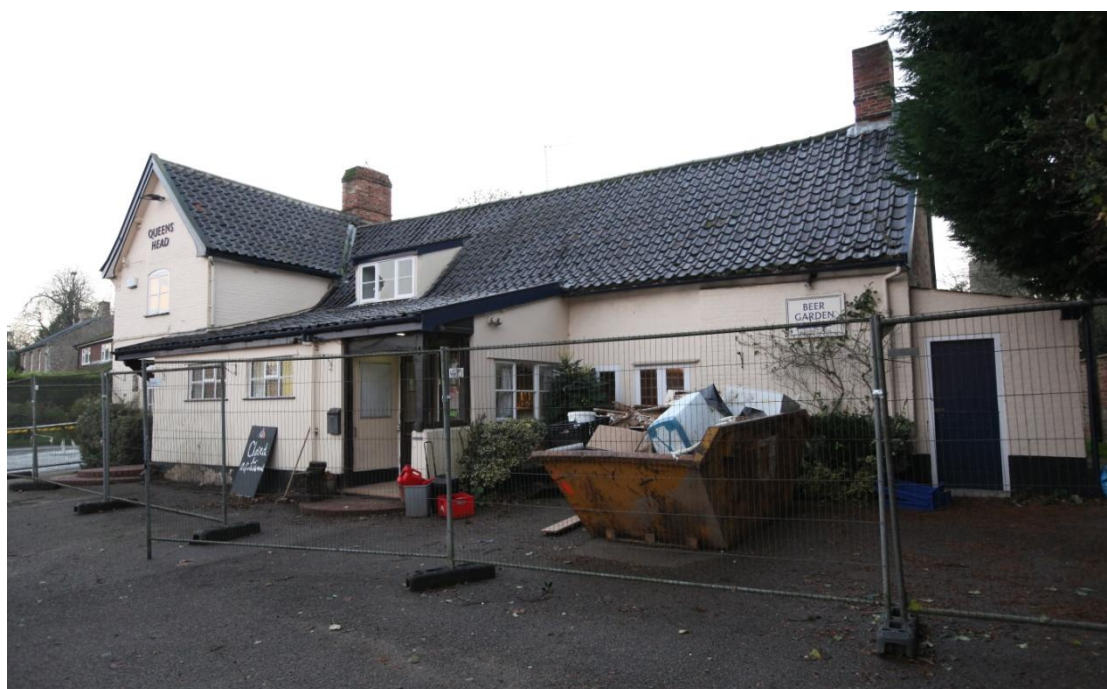
**Illus. 2. The 1.5 storied 16<sup>th</sup> century house with its glazed black pantiles and enlarged lean-to addition. The original timber-framed structure (A) terminated beneath the left-hand mullion of the dormer window but was extended in the late-18<sup>th</sup> century to meet the new cross-wing (B). The right-hand section of the facade has been rebuilt in brick.**

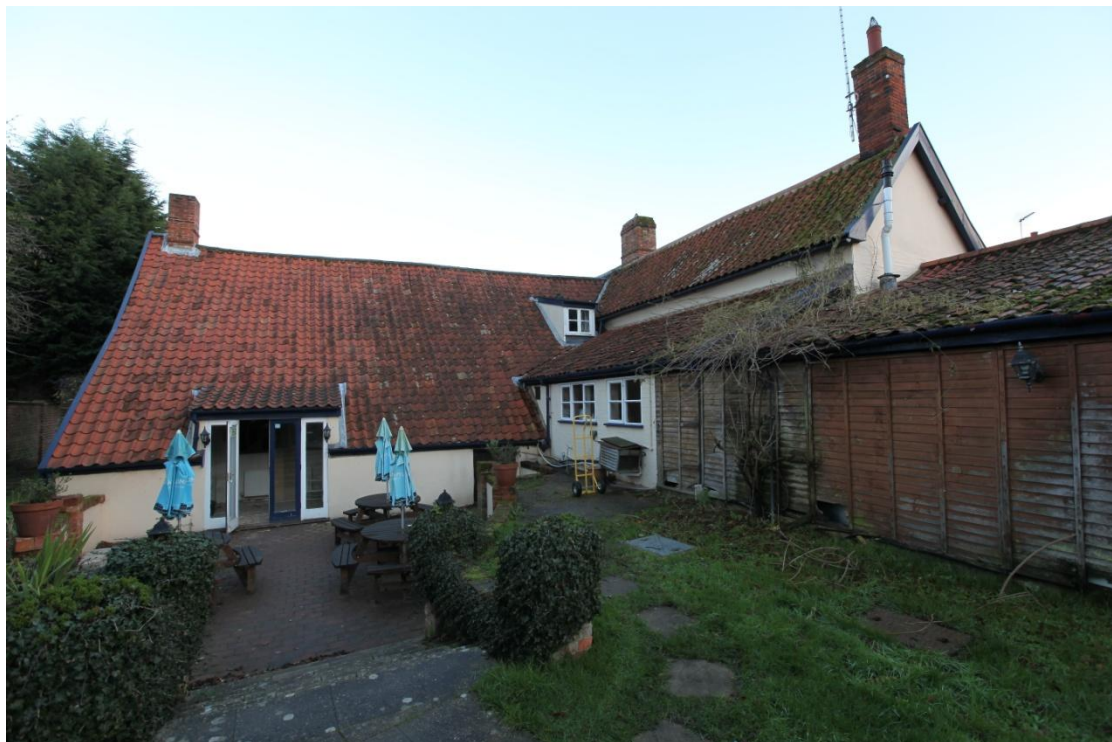
**Illus. 4. The rear of the inn, showing the unglazed pantiles of the 16<sup>th</sup> century structure (A) and its lean-to extension on the left and the formerly open-sided lean-to kitchen and adjoining sheds on the right. The roof of the lean-to kitchen has protected the original external pargeting and 19<sup>th</sup> century ‘Suffolk Pink’ of the 18<sup>th</sup> century wing (B), as shown in illus. 15 & 16 below).**

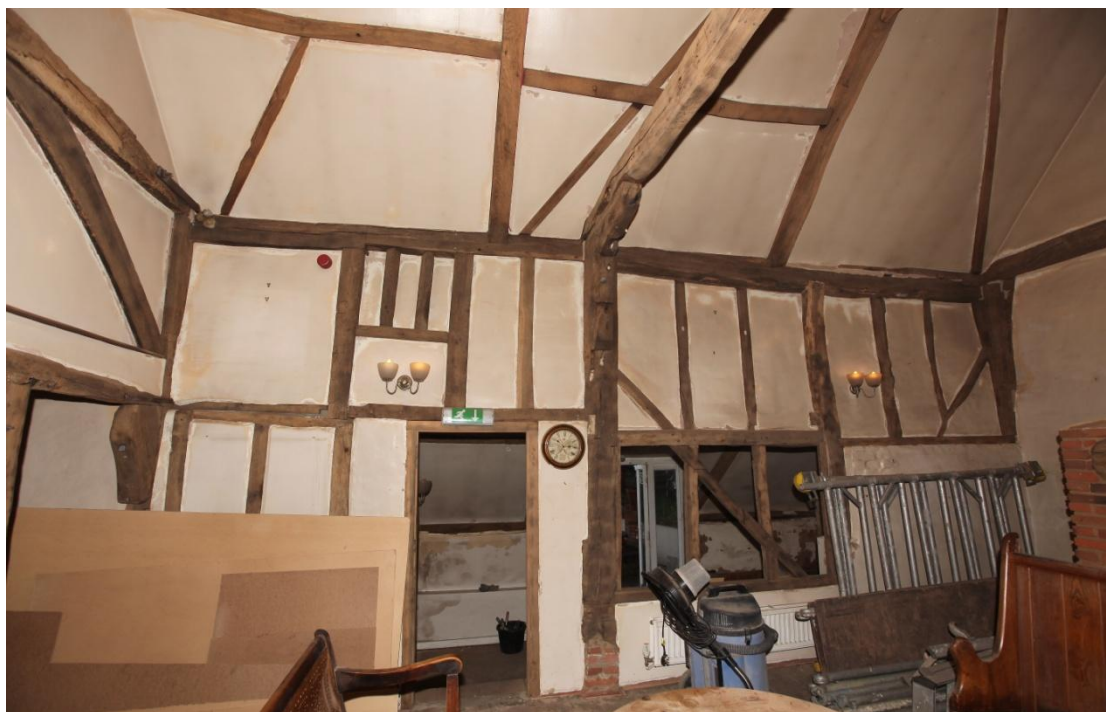
**Illus. 5. The rear (western) internal wall of the 16<sup>th</sup> century structure (A2). Now open to its late-18<sup>th</sup> century roof this room originally contained a ceiling and formed the two-bay hall of the Tudor house. The studs to the right of the central post have been replaced, leaving only the roof-plate *in situ*, but the diamond mullions of the first-floor window to the left are entirely original. 16<sup>th</sup> century windows typically lacked glass, but contained square mullions set diagonally and were closed by internal shutters. The outline of the blocked original back door can be seen to the left of the present door into the lean-to extension.**

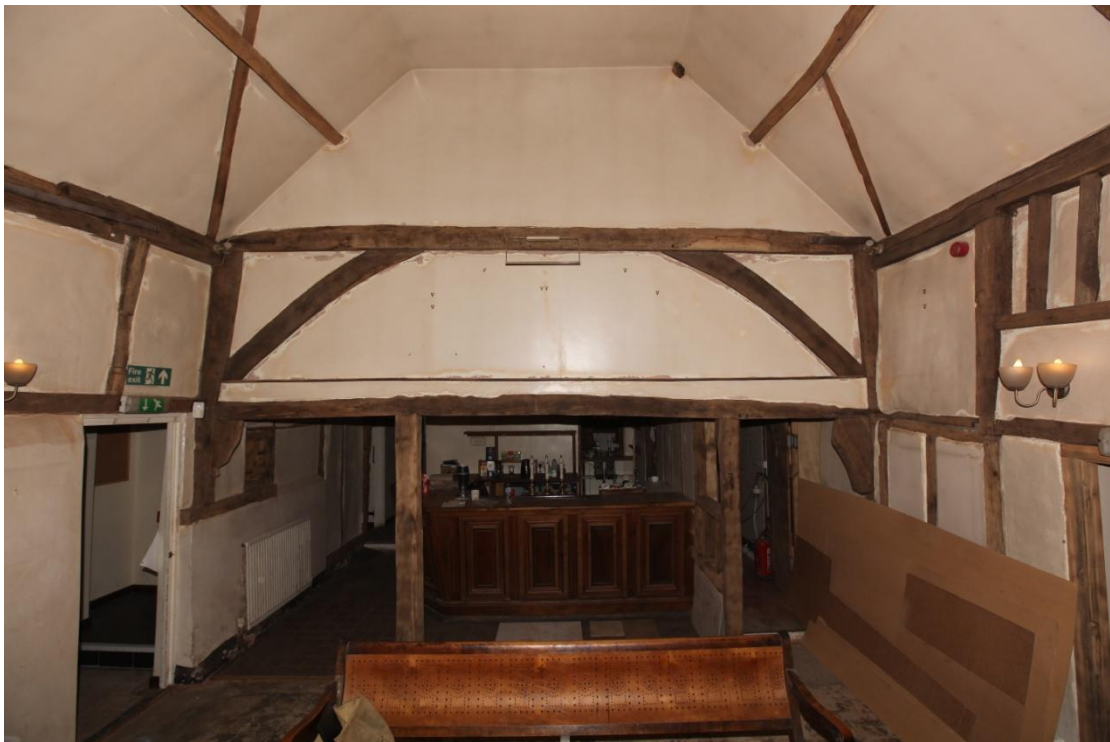
**Illus. 6**

**The ‘low-end’ of the 16<sup>th</sup> century hall (A2) seen from the north, with the original entrance door to the cross-passage on the left and the blocked back door on the right. The area above the bar ceiling was originally open to the missing chamber above the hall, with curved arch-braces supporting the original tie-beam. The two vertical studs that now support the horizontal mid-rail at ceiling height are later insertions, but the rail contains pegged mortises for original studs that formed a solid wall with two central doors and a third door against the back wall that opened onto a missing stair. Note the interesting 18<sup>th</sup> century hinged window shutter in the front wall to the left of the bar (A1).**

**Illus. 8. The late-18<sup>th</sup> century rebuilt roof of the Tudor hall, seen from the south. The tie-beam spanning the walls is also a replacement, along with its bolted knee-braces. The original tie-beam was arch-braced like its counterpart on the south (illus. 6), as indicated by mortises in the original wall posts.**

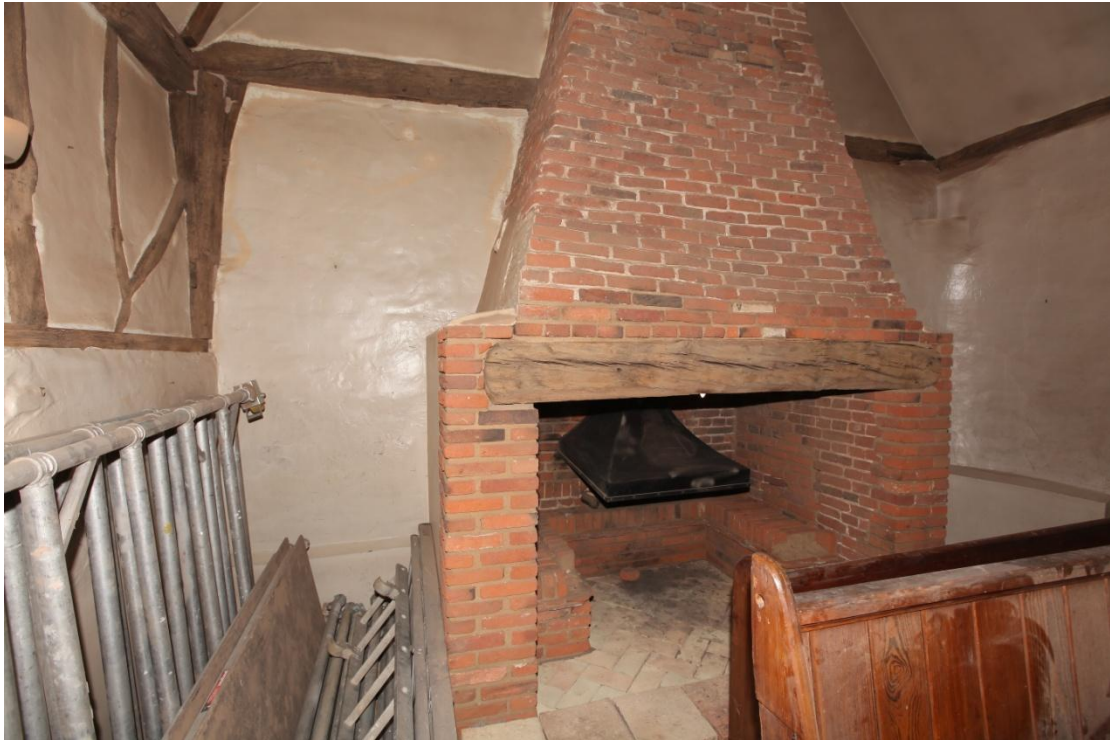
**Illus. 7. The 17<sup>th</sup> century chimney at the northern end of the 16<sup>th</sup> century hall (A2). The brick piers were rebuilt in the late-20<sup>th</sup> century and the timber lintel replaced. This fireplace may have operated in conjunction with the original ceiling, but may relate to the subsequent conversion of the hall into a bake-house or brew-house. The depth of the fireplace and the curved brickwork on the right suggests it was attached to a bread oven or copper.**

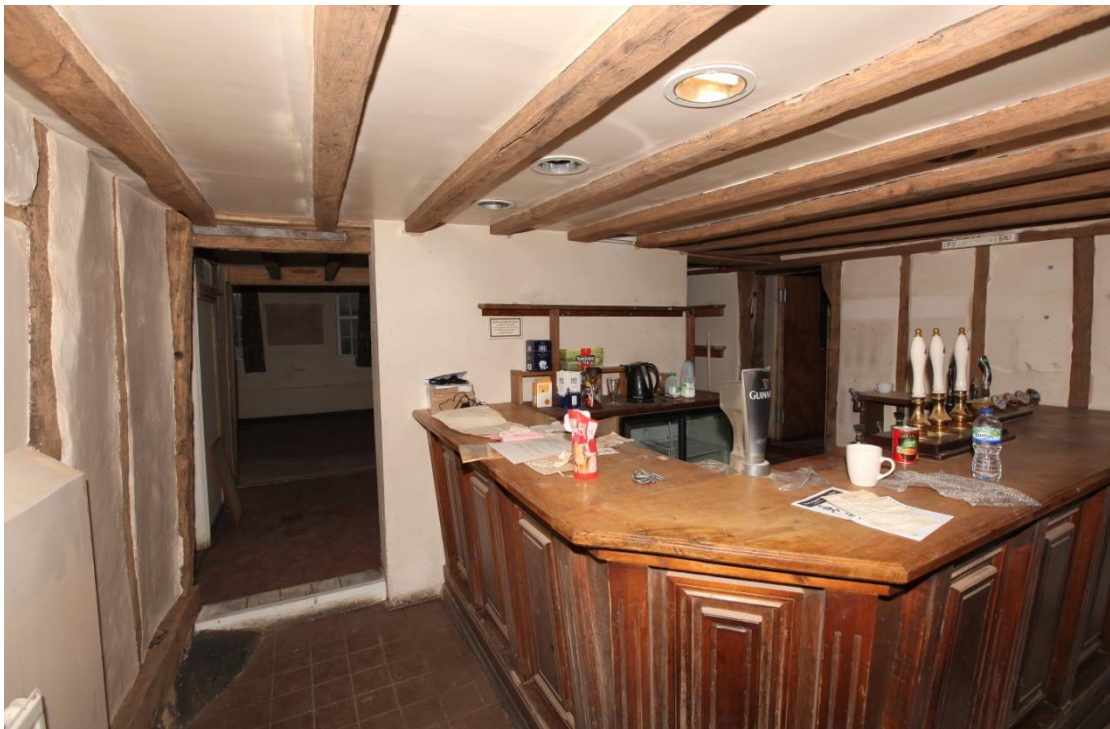
**Illus. 9. The service bay of the 16<sup>th</sup> century house (A1), seen from the north. The ceiling joists may be original but have been re-set and are now secured by late-20<sup>th</sup> century wire nails. This room was originally divided into a pair of store rooms with an axial partition and a stair to the rear (right). The solid wall in the centre of this image appears to consist only of late-20<sup>th</sup> century masonry but occupies the position of the original Tudor gable.**

The wall which currently separates the two bar areas occupies the position of the original southern gable of the 16<sup>th</sup> century timber-framed house (illus. 9). The rest of this gable has been removed in the past, leaving only its corner-posts *in situ*. The wall consists of rendered masonry and appears to have been rebuilt as part of an extensive programme of restoration in the early 1980s, as mentioned in the list description – although in the absence of further investigation the presence of 18<sup>th</sup> century brickwork cannot be ruled out. No 16<sup>th</sup> century fabric will be damaged by its removal.

**Illus. 10.** The original diamond-mullioned 16<sup>th</sup> century window in the back wall of the first-floor room above the bar area shown in illus. 9 above (A1, i.e. the original service chamber). The curved wall brace is also original, as is the ‘edge-halved and bridled’ scarf joint in the roof-plate to the right. Joints of this kind were standard in the 16<sup>th</sup> century but were quickly superseded after *circa* 1600.

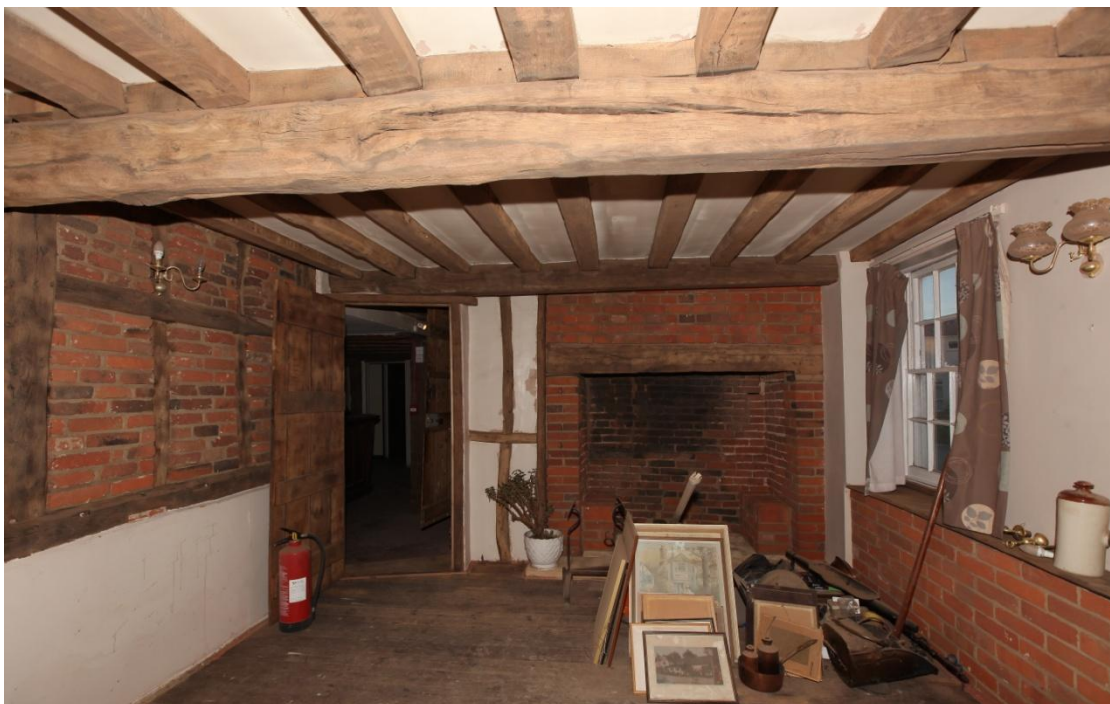
**Illus. 12. The front (eastern) room of the 18<sup>th</sup> century wing (B1) with the wall marking the original southern gable of the Tudor house adjoining the bar to the right. The plain, re-used ceiling joists here were formerly concealed by plaster, and the fireplace is a 20<sup>th</sup> century reconstruction.**

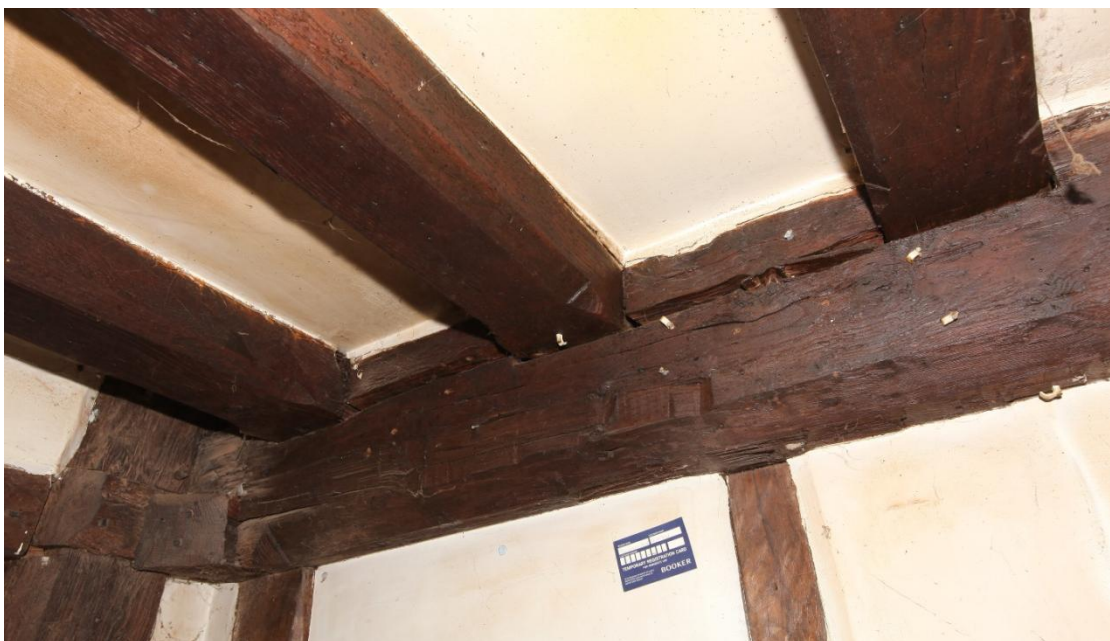
**Illus. 14.** The rear kitchen of the 18<sup>th</sup> century wing (B3) viewed from the west, showing the original solid partition adjoining the central room (B2). This room contains a complete, high-quality 16<sup>th</sup> century ceiling with neatly chamfered and step-stopped joists which extends into the central room. The common joists are tenoned to the contemporary principal joist, which is chamfered and stopped at both ends, but the vertical studs are nailed additions. Remarkably, there is no evidence of intact 16<sup>th</sup> century fabric in the external walls, and the entire ceiling appears to have been re-used from an older building of the same width.

The partition of vertical studs on a brick plinth (illus. 14) is an original feature of the late-18<sup>th</sup> century wing, which divided the rear kitchen (B3) from the central room entered from the road (B2). The kitchen was entered only by its present door from the rear yard (now the site of the modern lean-to kitchen). The insertion of a new door will require the removal of a single stud, nailed to the chamfered Tudor ceiling joist above, and the section of ground-sill and brick plinth beneath. The infill between the studs has been concealed or replaced by modern plasterboard.

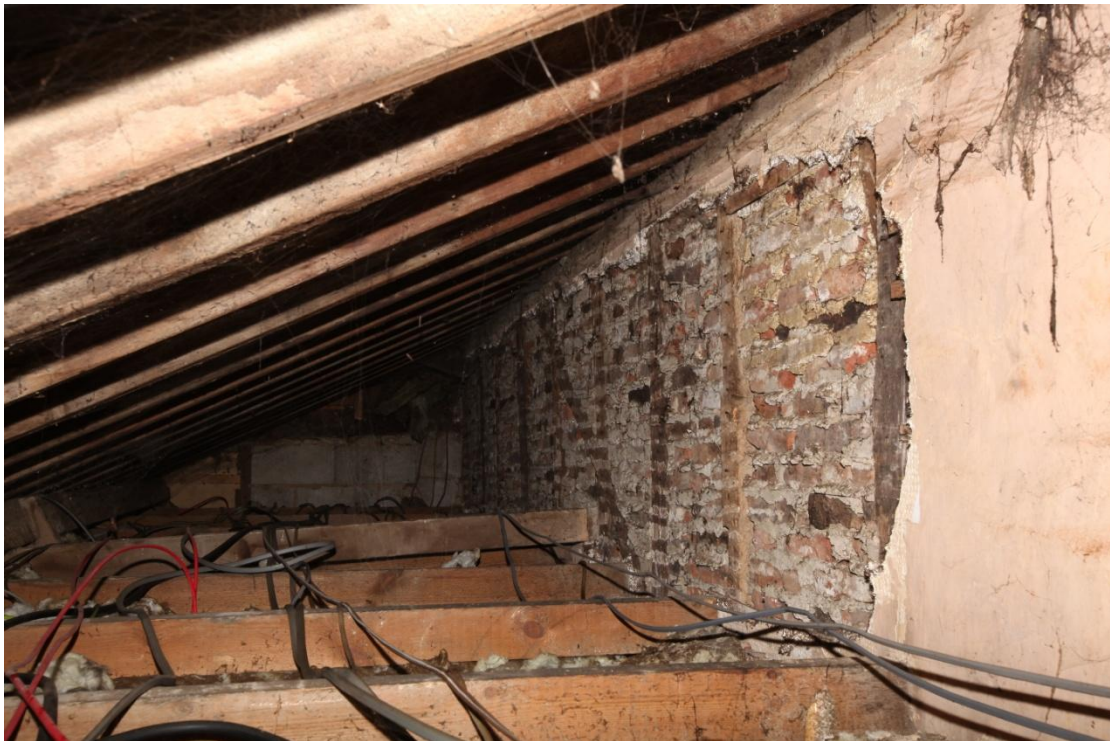
**Illus. 16. The typical 18<sup>th</sup> century roof structure of staggered butt-purlins in the northern internal wall of the rear wing (above rooms B3 to the left and B2 to the right).**
